## Járm információ

Rendszámtábla:LKF957

Gyártó:Volvo

Modell:S60

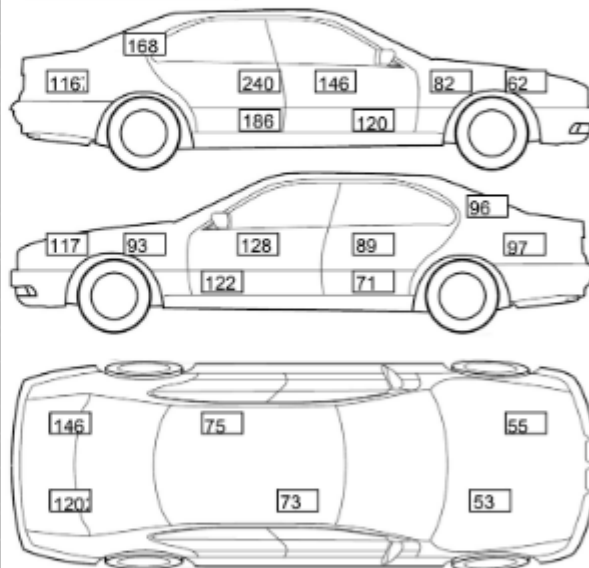
**Festékréteg vizsgálat**

Korához képest kitűnő karbantartott állapotú autó.. A jobb hátsó sárvédő/ív jh ajtó alja volt fényezve. Hátsó ajtó és a lökhárító szintén volt javítva.  
Bal első fényszóró cserélve (gyári Valeo) . Felső motortartó bak részben szakadt.  
Mégvétele javasolt autó.
